MCC Maintenance

Incident Summary

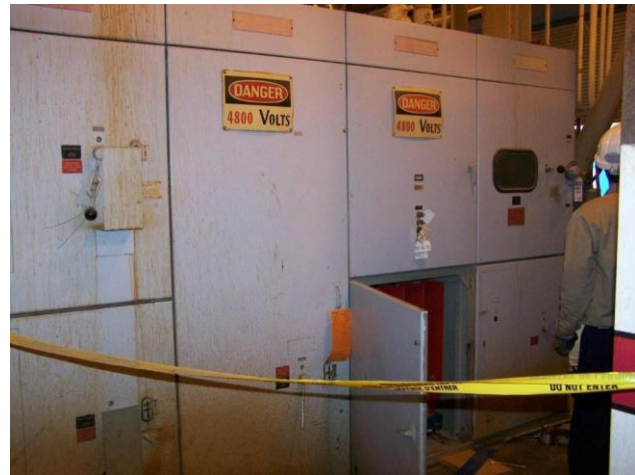
An electrical contractor received a severe electric shock as he was pushing a contactor into its cell after servicing it. The victim, part of a two-man crew, were performing preventative maintenance on an MCC. The victim received a 4800V shock when his hands were making contact with the contactor's bus.

1. Crew did not consider hazards involved with more than one worker simultaneously working on a multi-unit machine.
2. Crew did not review schematics of equipment or line diagrams.
3. No hazard assessment was performed by the customer and contractor crew.
4. Safe work permit did not identify the gaps in the contractor's work procedure.
5. The crew did not lock and tag out in accordance with OHSA.
6. The Lead Electrician did not communicate to the victim that was exercising the racking handle.
