Re: Fire Safety

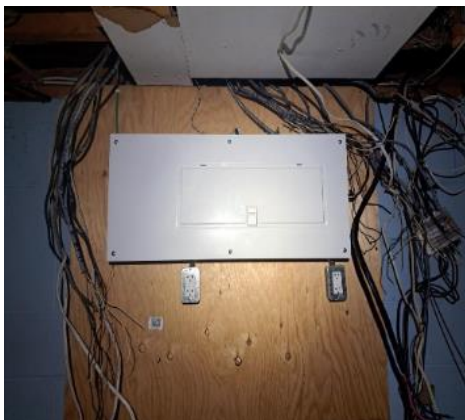
Inspect the service inside and outside of the affected building. If there is any damage due to flame, smoke, heat or water, the service must be replaced. All branch circuits should be left out of the panel with only a new GFCI receptacle or two left at the panel for restoration personnel. All repairs require a notification and connection authorization with ESA.

Panel Replacement After Fire
