June 2019

Supersedes 16-11-FL

Luminaires retrofitted with T8 fluorescent tubes

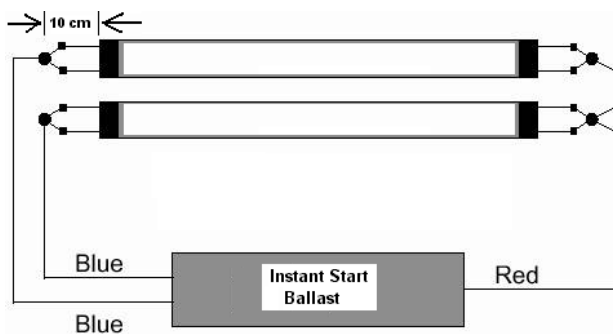
Figure F1 – Correct wiring method

Figure F1 shows correct wiring configuration. Check that all lamp holder contacts are in good condition and show no signs of arcing or pitting.

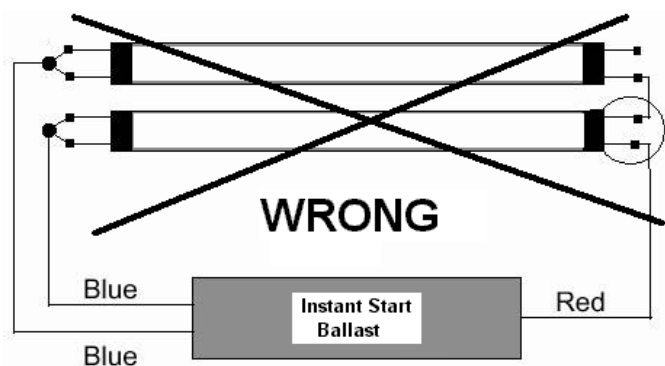
Figure F2 - Incorrect and not acceptable wiring method or its electrical equivalent

Figure F2 shows incorrect and unacceptable wiring configuration. This method uses T8, bi-pin, instant-start lamp holders, which have a factory installed jumper between the two lamp contacts.

No other wiring configuration is recommended. Incorrect wiring configurations allow excessive current to pass through the lamp(s) cathodes, potentially overheating the lamp base and the lamp holder excessively, resulting in lamp holder deformation, melting or charring and failure.
