Luminaires retrofitted with T8 fluorescent tubes

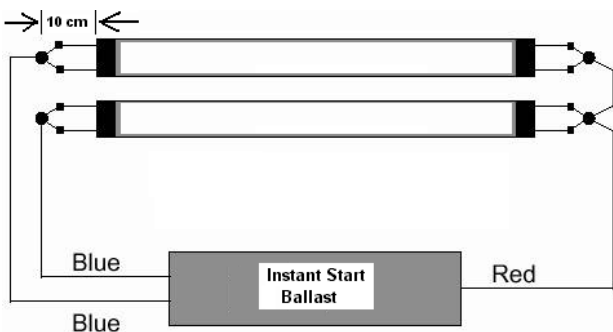
Figure F1 – Correct wiring method

Figure F1 shows correct wiring configuration. Check that all lamp holder contacts are in good condition and show no signs of arcing or pitting.

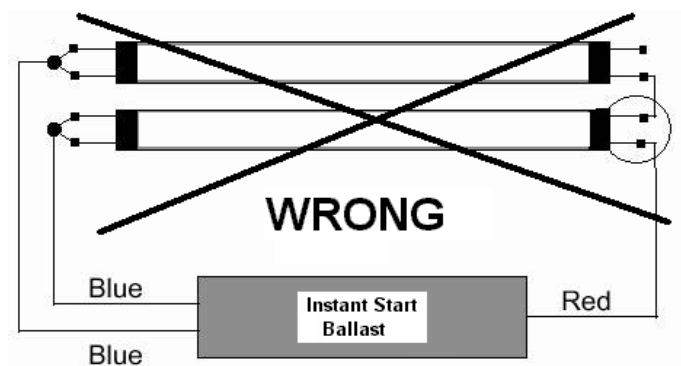
Figure F2 - Incorrect and not acceptable wiring method or its electrical equivalent

Figure F2 shows incorrect and unacceptable wiring configuration. This method uses T8, bi-pin, instant-start lamp holders, which have a factory installed jumper between the two lamp contacts.

No other wiring configuration is recommended. Incorrect wiring configurations allow excessive current to pass through the lamp(s) cathodes, potentially overheating the lamp base and the lamp holder excessively, resulting in lamp holder deformation, melting or charring and failure.
