Polarity identification for photovoltaic dc system conductors

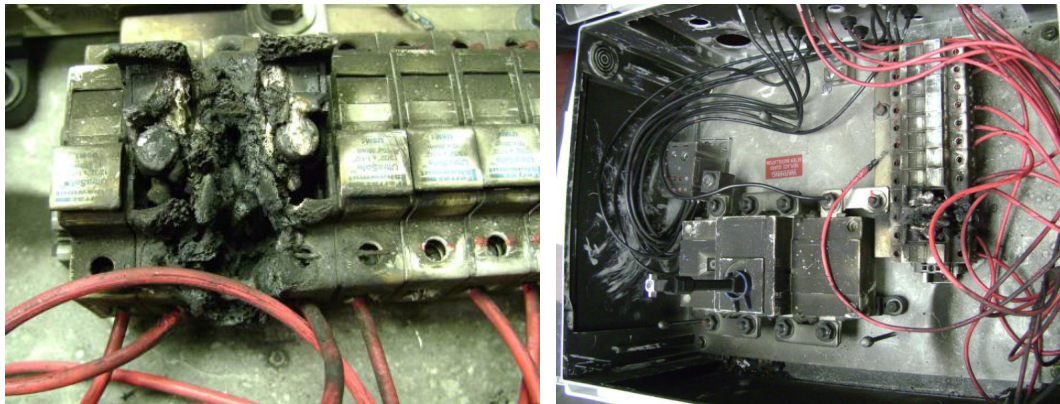
In Ontario we have experienced failure during installations that are suspected to have been caused by increased potential when a single array's wiring was reversed to a combiner box. Minor contaminants, such as moisture or dirt, have started self sustaining dc arcing faults, even with the fuses in the open position.

Photo F1 below shows an example of PV equipment (combiner box) failure as a result of reversed PV source circuit polarity.

Photo F1 – Accident resulted when polarity of dc sources was reversed

The Ontario Electrical Safety Code (OESC) Rule 64-212 requires dc Photovoltaic circuit conductors to be coloured or coded to identify polarity, see Photo F2.

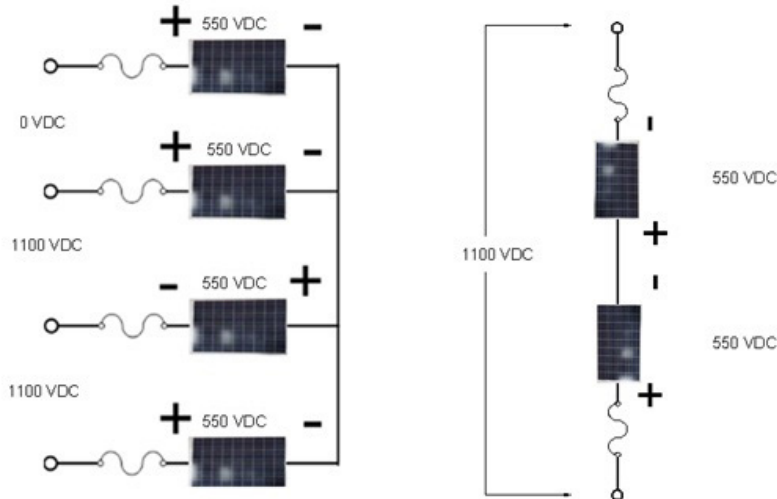
Unlike traditional ac systems where connection of incorrectly identified conductors will cause reversal of motors or an overcurrent device to operate, reversal of dc sources can create series circuits that will produce voltages well in excess of the rated system voltage. Diagram F1 below explains the circuit analogy of a reversed PV source circuit polarity.

Diagram F1 – Reversed polarity of dc sources

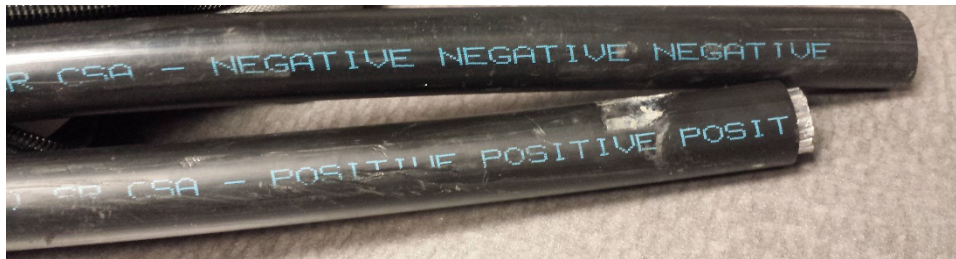
Photo F2 – Example of the required marking to identify polarity
