Luminaires retrofitted with T8 fluorescent tubes

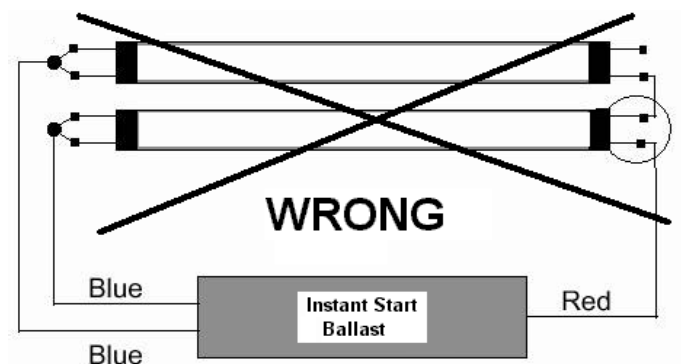
Figure F2 - Incorrect and not acceptable wiring method or its electrical equivalent

Figure F2 shows incorrect and unacceptable wiring configuration. This method uses T8, bi-pin, instant-start lamp holders, which have a factory installed jumper between the two lamp contacts.

No other wiring configuration is recommended. Incorrect wiring configurations allow excessive current to pass through the lamp(s) cathodes, potentially overheating the lamp base and the lamp holder excessively, resulting in lamp holder deformation, melting or charring and failure.
