In-Line Solid Blade Switch Safety

Distribution Company Awareness

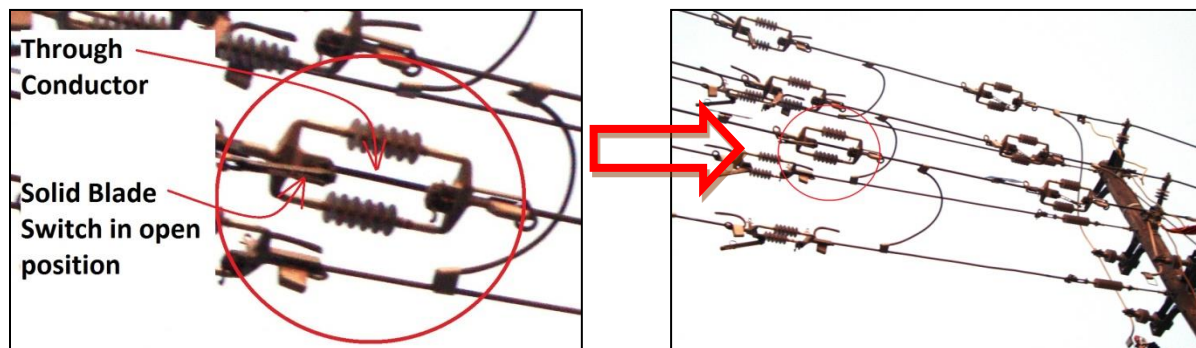
Prior to replacing the fuse assembly, one member of the crew opened 6 other in-line solid blade switches to expand the safe work zone unaware that the lower phase conductor was still energized even though the switch was in the open position.

Normally, there are causal factors involved for any incident to occur. One of the causal factors in this incident was a mistake at the time of the original installation. The conductor between the in-line solid blade switch was not cut, therefore the energy bypassed the open point of the switch.

Crews should examine any existing installation for any errors such as the conductor running through the in-line solid blade switch allowing the flow of energy to bypass the switch blade when in the open position.

Prior to operating of the in-line solid blade switch, crews should inspect the switch to ensure the conductor has been cut.
