In-Line Disconnect Switches

Distribution Company Awareness

This bulletin addresses issues with a type of In-Line Disconnect Switch that can cause safety concerns.

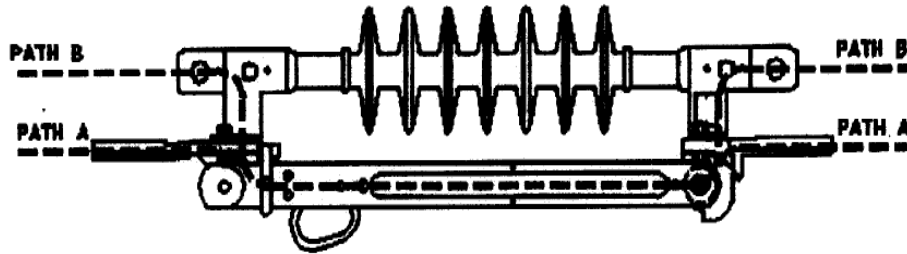
The switch type shown above has 2 current paths. “Path A” indicates the desired current path, through a wedge connector, to the terminal pad, and through the switch blade. If “Path A” develops a high resistance, more current will be forced through the undesired path indicated by “Path B”. The current along “Path B” can cause heating issues, leading to end fitting separation.

- Crews are made aware of this issue and inspect for any visible signs of cracking before operating the switch;
- Proper connections are made, including proper cleaning and abrading of the conductor and the use of oxide inhibitor;
- Engineering investigate the use of dead-end insulators to increase the impedance of current through “Path B”; and
- Infrared testers are aware these switches may have elevated heating at the compression connectors.
