Subject: IMPORTANT PRODUCT PERFORMANCE BULLETIN
 Potential DBU Expulsion Fuse Nonconformance at Faults Below 2kA
 Manufacturing Date Code Range is 01/01/2000 to 08/18/2004

HAZARD DESCRIPTION – Eaton DBU Expulsion Fuse Nonconformance:

Additional information requests, including report(s) and follow-up information, may be directed to ESA. Please be prepared to quote Bulletin “DSB-03/05”.

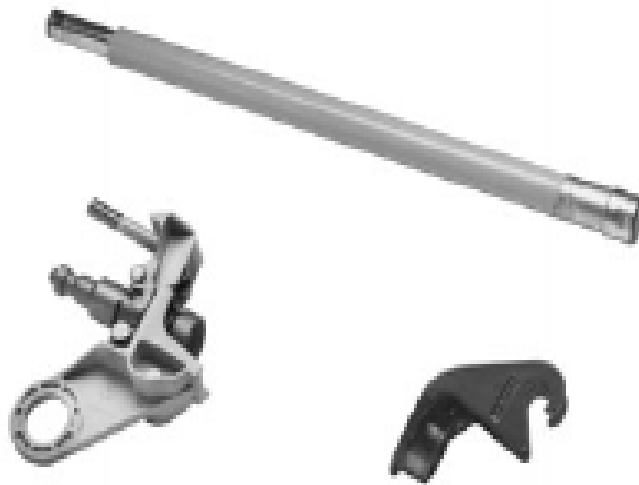
There is some concern that the Eaton “Product Performance Bulletin” regarding Eaton’s DBU expulsion fuses, within the manufacturing date code range between 01/01/2000 to 08/18/2004, may not have reached all LDC users of this product.
