Electrical Distributor Technical Bulletin

In-Line Disconnect Switches

Electrical Distribution Safety

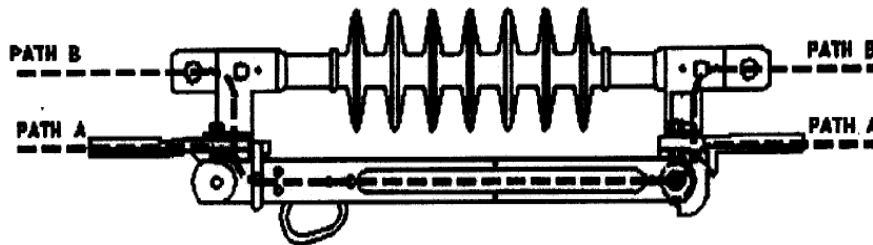
With the switch type shown above there are 2 current paths. "Path A" shows the desired current path, through a wedge connector, to the terminal pad, and through the switch blade. If "Path A" develops a high resistance, more current will be forced through the undesired path indicated by "Path B". The current along "Path B" can cause heating issues, leading to end fitting separation.

ESA recommends that crews are made aware of this issue and inspect for any visible signs of cracking. It is important that proper connections are made, including proper cleaning and abrading of the conductor and the use of oxide inhibitor. LDCs could investigate the use of dead-end insulators to increase the impedance of current through "Path B".

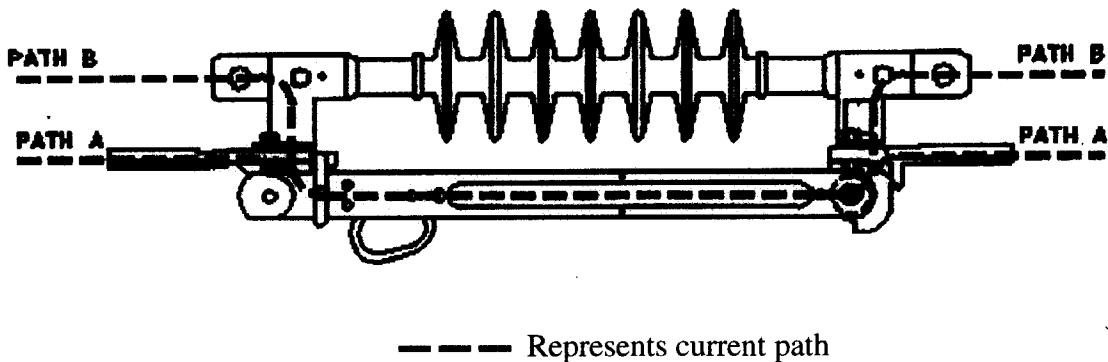
Figure 1. In-line Disconnect shown with parallel current path

The design of the in-line disconnect results in two parallel current paths (see Figure 1). Under normal circumstances path A has a much lower total resistance, and thus the majority of the current flows through path A. All materials and joints in this path are carefully designed to ensure low resistance, and to meet the applicable ANSI temperature rise requirements. It is believed that in the aforementioned incidents that the jumper terminations were not properly made, resulting in an abnormally high resistance in path A. As a result, path B was forced to carry more current than it was designed for. Overheating of the aluminum insulator end fittings resulted. If sufficient overheating of these components occurs, the aluminum will anneal, which can cause end fitting separation.

It is important that proper terminations be made, including proper cleaning and abrading of the conductor, and the application of a suitable termination compound such as Penetrox. In addition, it is important to insure that aluminum-to-copper connections are properly made. In this case, the optional tin-plated terminal pads should be selected.

Recent testing has proven that the in-line devices will perform reliably if the terminations are correct. Utilities should review their termination practices, and inspect units which they believe might be suspect. A combination of infra-red and visual inspection of the insulator end fittings for cracks or slippage would be the most effective means of verification.

To help make In-line Disconnects and Fuses more immune to this phenomena, all future units will incorporate an insulating material to electrically path A from path B. Please note that if improperly terminated, this does NOT eliminate the risk of end fitting separation due to overheating, but it may reduce it. All new units will incorporate an "R" number revision to their catalogue numbers. Production of these new units will begin December 1996. Additionally, K-Line is conducting on-going research to find methods and materials which will tolerate even higher temperatures prior to damage.
