Electrical Distribution Safety

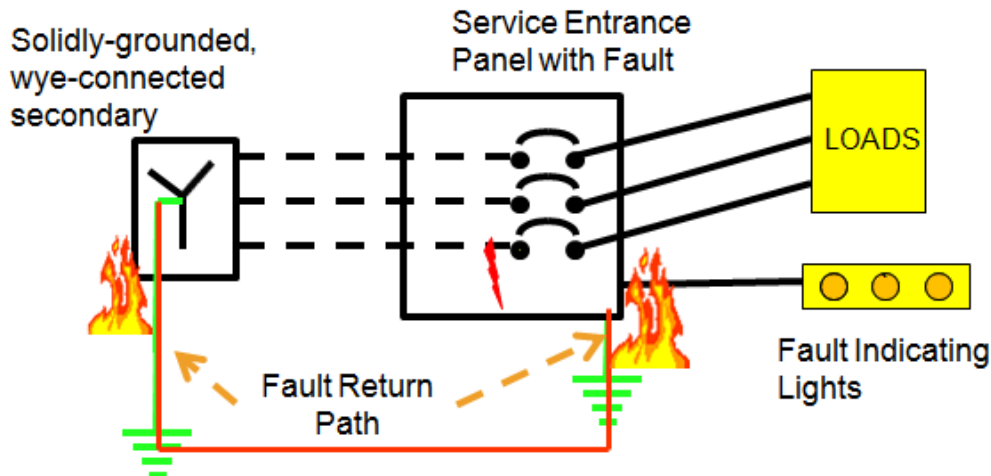
SCHEMATIC: POTENTIAL FAILURE MODE

*Note – Fault Indicating Lights were not always a requirement within the Ontario Electrical Safety Code, at one time was only a recommendation.
