FLASH

Flash 25-12-FL Supersedes 22-24-FL

Polarity identification for photovoltaic dc system conductors

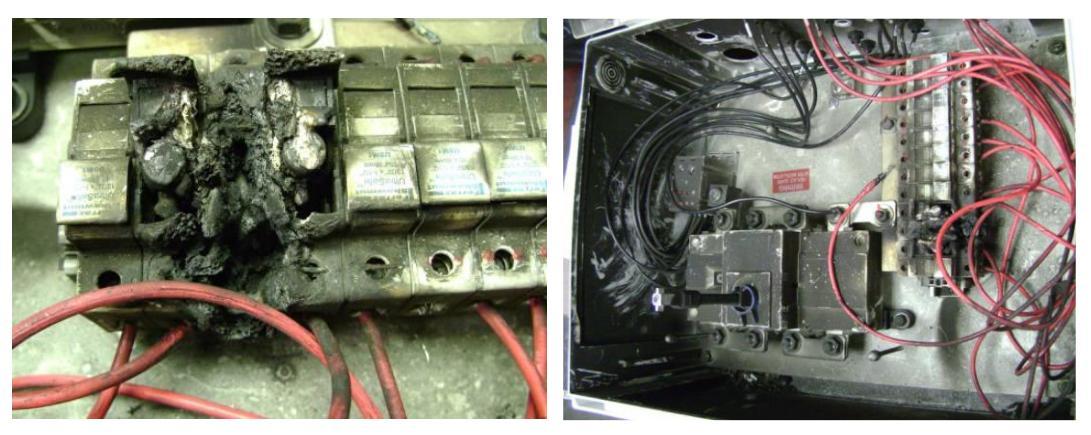
ESA has been involved in several fire investigations that resulted when polarity of PV (dc) source and/or output circuit wiring was accidentally reversed during installation. One of the main contributing factors was the lack of marking and/ or improper field marking of conductors which presents many opportunities for errors and consequently dangerous failures.

In Ontario we have experienced failure during installations that are suspected to have been caused by increased potential when a single array's wiring was reversed to a combiner box. Minor contaminants, such as moisture or dirt, have started self sustaining dc arcing faults, even with the fuses in the open position.

Photo F1 below shows an example of PV equipment (combiner box) failure as a result of reversed PV source circuit polarity.

Photo F1 – Accident resulted when polarity of dc sources was reversed

The Ontario Electrical Safety Code (OESC) Rule 64-212 requires dc Photovoltaic circuit conductors to be coloured or coded to identify polarity, see Photo F2.

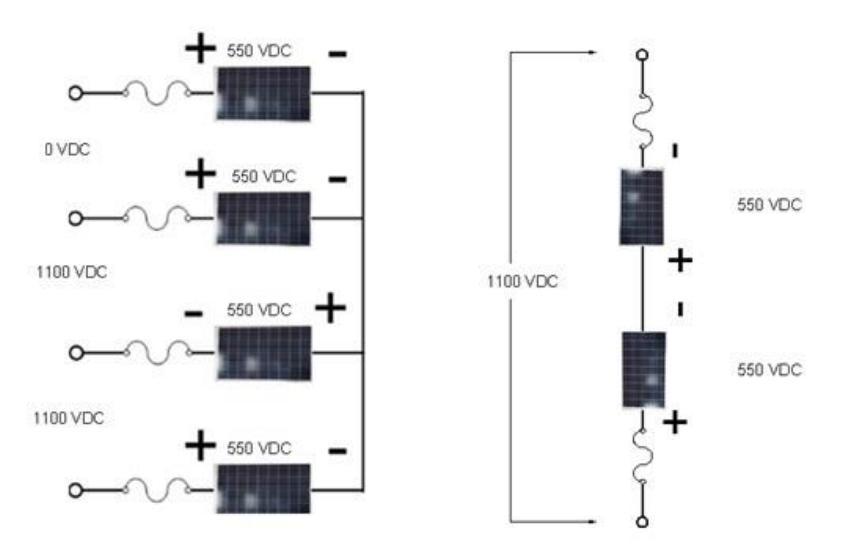
Unlike traditional ac systems where connection of incorrectly identified conductors will cause reversal of motors or an overcurrent device to operate, reversal of dc sources can create series circuits that will produce voltages well in excess of the rated system voltage. Diagram F1 below explains the circuit analogy of a reversed PV source circuit polarity.
