Shock Hazard with Tall (metallic) Audio Visual Carts

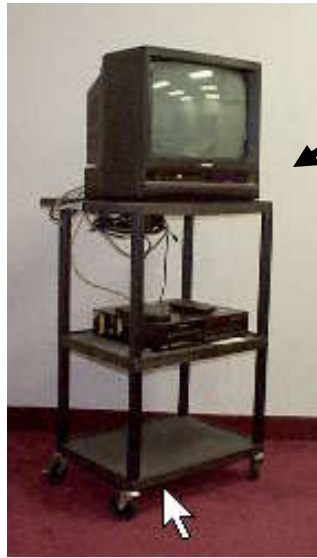
During an inspection in a school kindergarten room, an Inspector found a metal audiovisual utility cart, where the metallic portion of the cart was energized.

This dangerous condition poses a serious shock hazard to persons coming in contact with the cart or equipment connected to the cart.

Typical Audio
Visual Cart

1. Inspect all metallic carts with a power bars bolted to it.
2. The attachment cap should have all three prongs intact and in good condition. Plugs with broken ground pins are unsafe and should not be used.
3. If a faulty cart is suspected, Do Not Use until a qualified person tests and deems the cart is safe.
4. The polarity and ground continuity of the power bar should be tested using a polarity tester (see diagram below). Also test for any potential to ground with an approved voltage meter.
5. Carts with power bars that are not polarized or indicate potential to ground when tested, shall be taken out of service immediately.
6. All carts and power bars should be inspected from time to time and repaired or replaced as necessary to ensure the safety of the user.

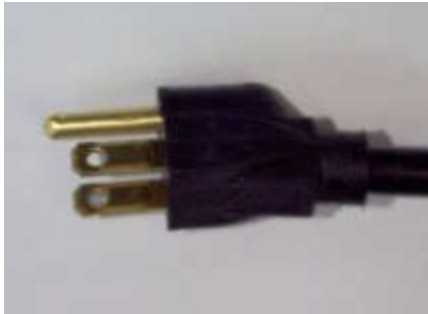
Further investigation has identified numerous other metallic utility carts in educational facilities and offices that are energized when the power bar on the cart is connected to a wall outlet. The molded cord cap on the flexible supply cord has been found to fail as a result of abuse, excessive use or poor connection of the grounding in the molded cord cap.

Attachment Cap
