June 2019**Supersedes 16-08-FL**

Electrical hazards found at sports fields

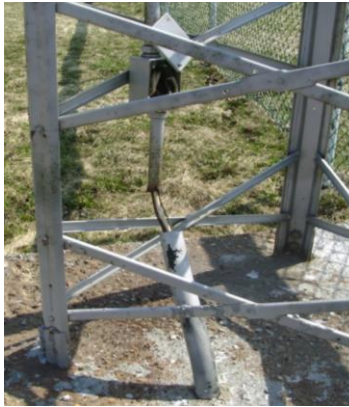
- Some towers used to support lighting are in a deteriorated condition.
- Original installation may have been modified, exposing energized conductors (See Photo F1).
- Box covers are missing or improperly installed.
- Electrical Metallic Tubing (EMT) was commonly used a number of years ago as raceway for electrical wiring in outdoor installations which included sports fields.
 - EMT can become rusted and break where it has been used in exposed installations.
 - EMT may shear off where it exits concrete as it deteriorates.
 - Damaged and deteriorated EMT may pose a shock hazard through loss of bonding continuity.

Photo F1 – Deteriorated and incomplete conduit system with exposed conductors

Once deterioration or damage is identified, repairs should be made immediately. When making repairs, the requirements of the current revision of the OESC should be considered. When it is necessary to replace all or part of an electrical installation it should be confirmed that any such work complies with the current requirements of the OESC and that a notification (permit) is obtained for the work as per Rule 2-004.

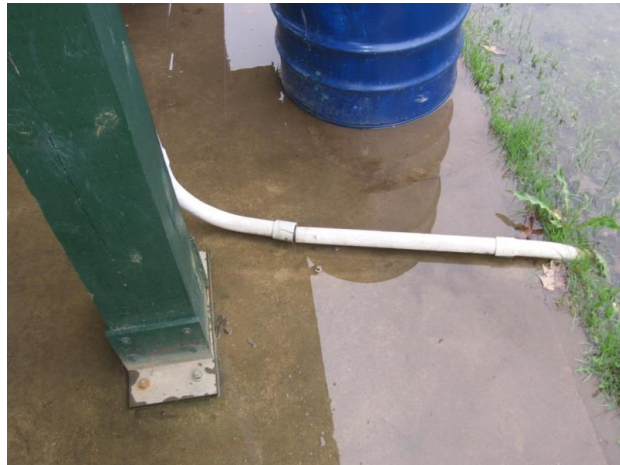
- PVC conduit damaged by snow removal or lawn care equipment, potentially exposing wires.
- Conduits are not protected from ongoing mechanical damage, see Photo F2.
- Conduits concealed by snow during winter months, creating the potential for additional damage.

Photo F2 – Improperly protected conduit (Damaged)

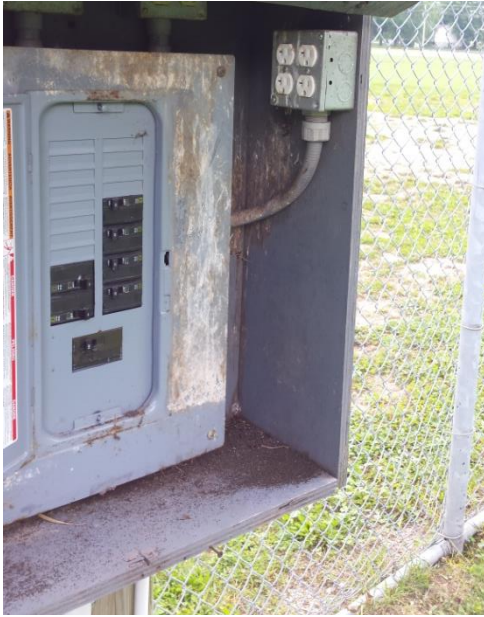
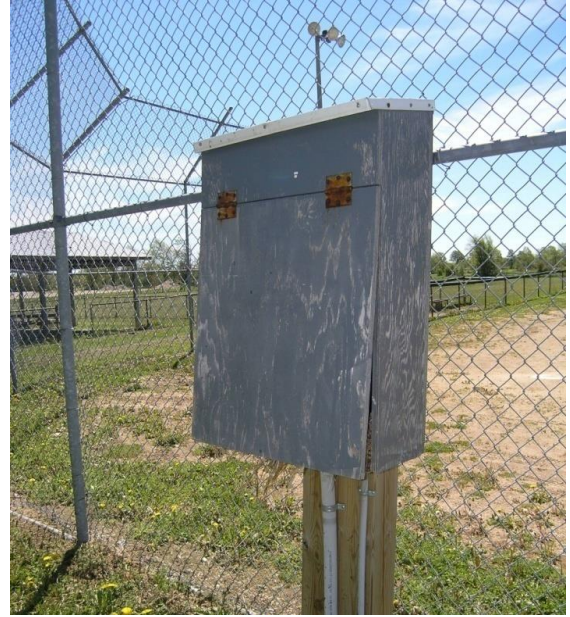
- Electrical panels rusting.
- Electrical panels with unused openings as a result of missing panel fillers which exposes the live bus to anyone putting their hands on or near the panel.
- Electrical panels protected by wooden enclosures which are not weather-proof or are deteriorated.
- Electrical panels are not locked.
- Evidence of animal nesting.

Some of the above conditions are shown on Photo F3 below.

Photo F3 – Accessible and Deteriorated Enclosure
