## Installation of communication wiring around electrical equipment

# FLASH

May 2022

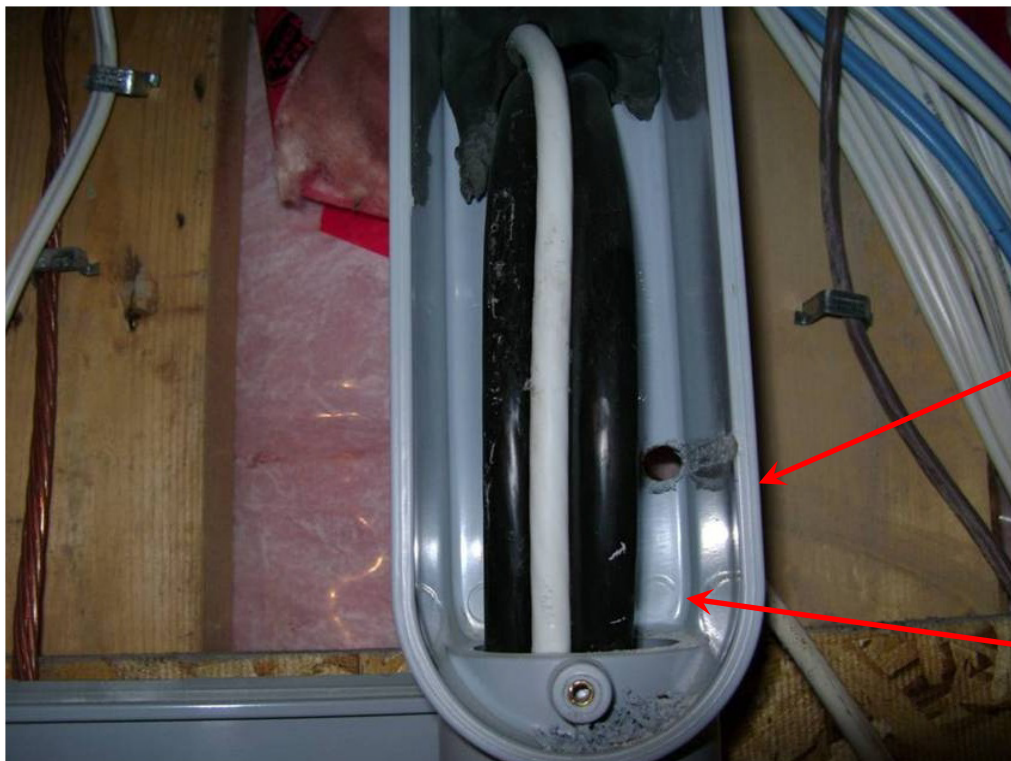
**Photo F1**

A Cable installer drilled a hole through the wall from the outside, without realizing the hole penetrated into the electrical conduit fitting and almost interacted with the energized wire.

Energized wire

The root cause of these incidents is failure to ensure the area is clear and safe for drilling. These incidents could have been avoided by measuring the inside and outside of the structure where the intended hole is to be located for cable routing.

**These incidents did not need to happen! Proper job planning, safety training and ongoing safety awareness would go a long way to eliminating these hazardous incidents.**

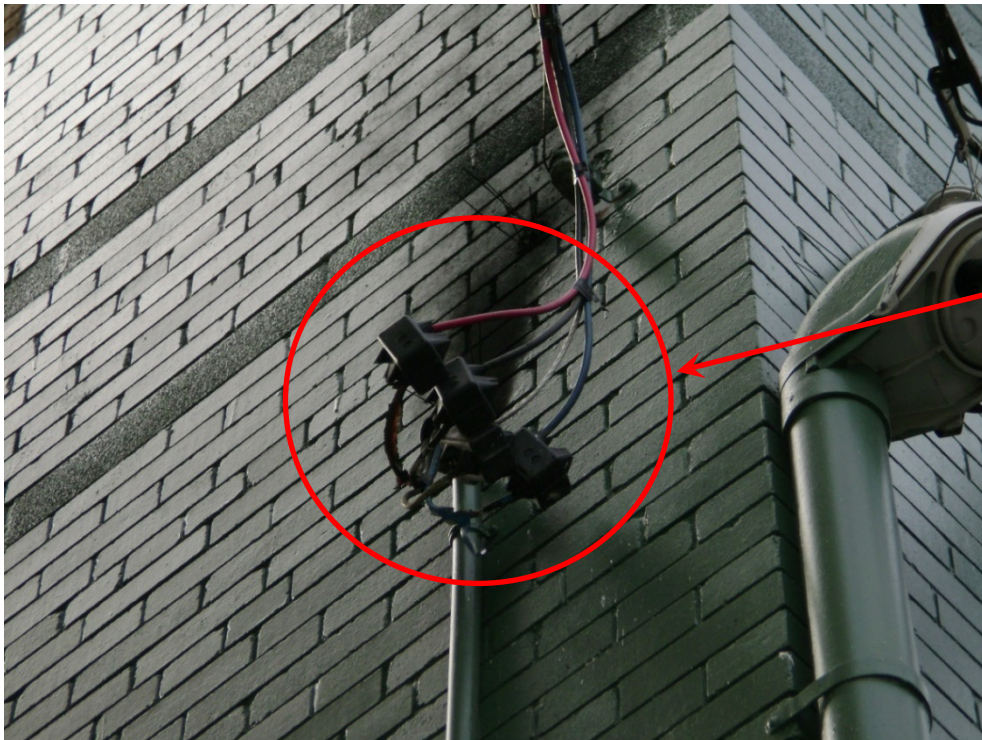
Photo F3

The arc flash went up the conduit and exited at the top of the mast. The arc flash also entered into the building and burnt out the service switch and meter base.
