## Electrical Safety Authority Warns of Potential Shock Hazard Associated with the incorrect installation of In-line Fuse Holders

# FLASH

May 2022

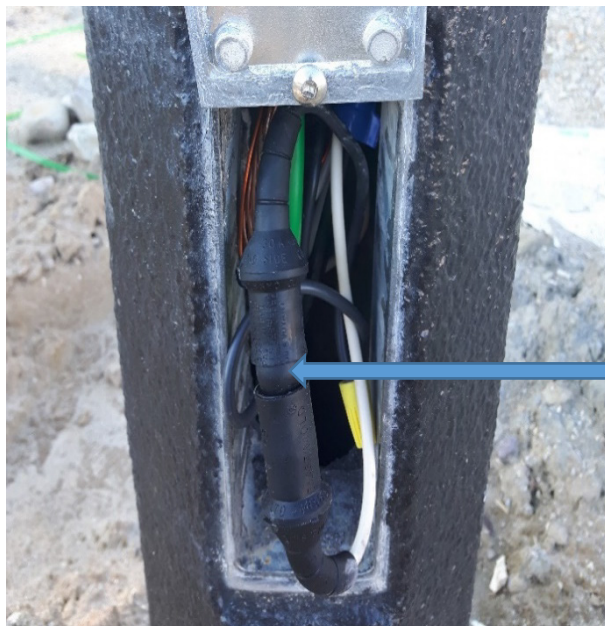
### **Example of incorrectly assembled Fuse Holder with a wide gap between holder halves**

Wide Gap between  
fuse holder halves  
when assembled

End users and contractors are cautioned to ensure that they follow the manufacturer's installation instructions when using the Thomas & Betts In-line Fuse Holder Models 65 and 65U.

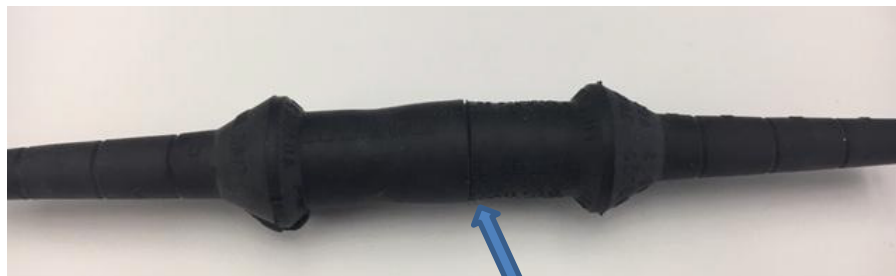
## Correctly Assembled Fuse Holder

When properly mated, the seam between housings should not exceed 1/32 inch as outlined in the manufacturer's instructions
