Aluminum wiring in residential installations

Issues with aluminum wiring

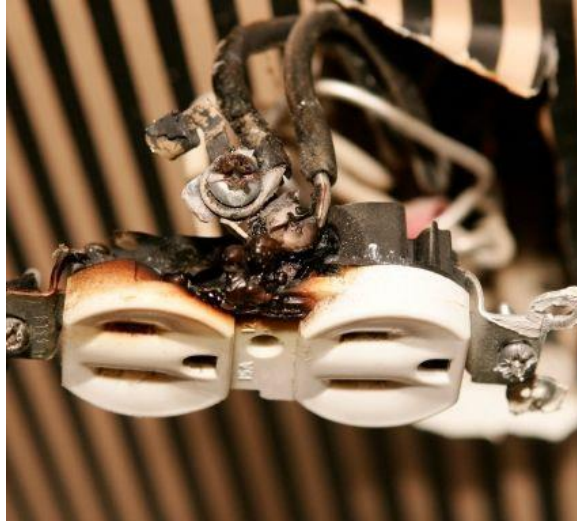
Reported problems with aluminum wiring have been related to the overheating and failure of aluminum wiring terminations. This is due to the tendency for aluminum to oxidize and its incompatibility with devices designed for use with copper wiring. Warm

cover plates or discolouration of switches or receptacles, signs of arcing within switches or receptacles as per photo F1, flickering lights, or the smell of hot plastic insulation may be evidence of these problems.

Photo F1 – Failure of aluminum wiring terminations

If an owner is aware or has discovered that the house is wired with aluminum wiring and the original devices are not marked as suitable for aluminum wiring, there is a potential for failure which could lead to a fire, as per Photo F1. Aluminum-wired connections have been known to fail and overheat without any prior indications or problems. Do not wait for signs of overheating of the termination or signs of arcing within switches and receptacles. ESA strongly recommends eliminating a hazard by replacing the original devices with aluminum rated and properly marked devices (or have copper tails installed).

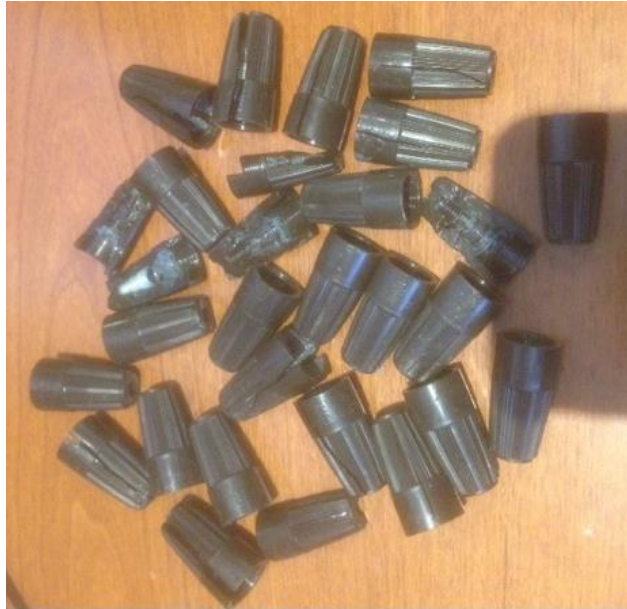
It has been brought to the attention of ESA that the excess use of **non-petroleum** based inhibitors may result in the failure of approved wire connectors. Photo F3 shows an example of a failure when non-petroleum based inhibitor was used for copper to aluminum connections. The “Oxide Inhibiting compound” and connector manufacturers’ shall be consulted to ensure the compound used is appropriate for the application.

Photo F3 – Non-Petroleum based inhibitor failures

Unless the termination or splice is approved and so marked for use without Oxide Inhibitors, OESC Rule 12-118 2) requires a joint compound, capable of penetrating the oxide film and preventing its reforming, be used with **stranded** aluminum conductor connections.

The compound is conductive and should be used sparingly and any excess compound should be removed.
