## **Electrical Safety Authority Warns of Potential Shock Hazard Associated with the incorrect installation of In-line Fuse Holders**

# FLASH

May 2025

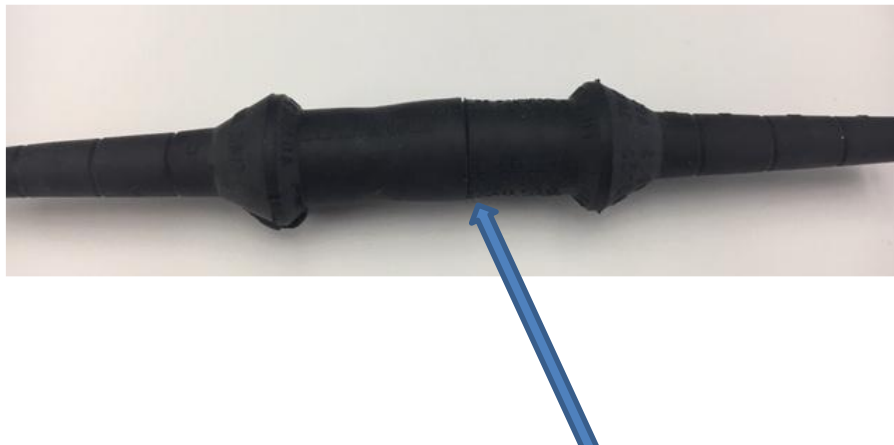
## Correctly Assembled Fuse Holder

When properly mated, the seam between housings should not exceed 1/32 inch as outlined in the manufacturer's instructions
