Energized Temporary Distribution Work

Distribution Company Awareness

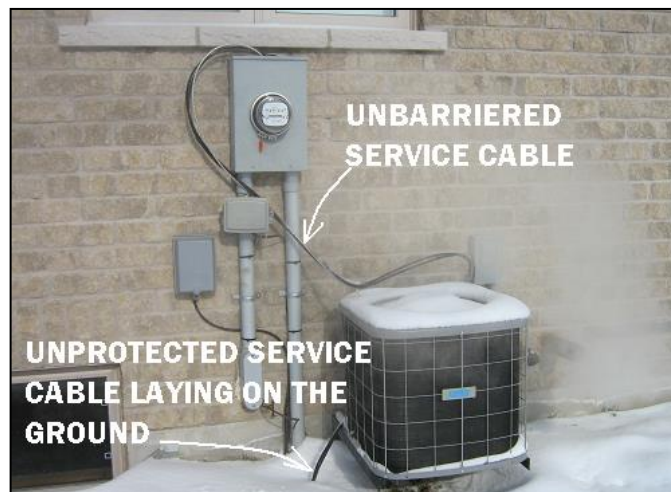
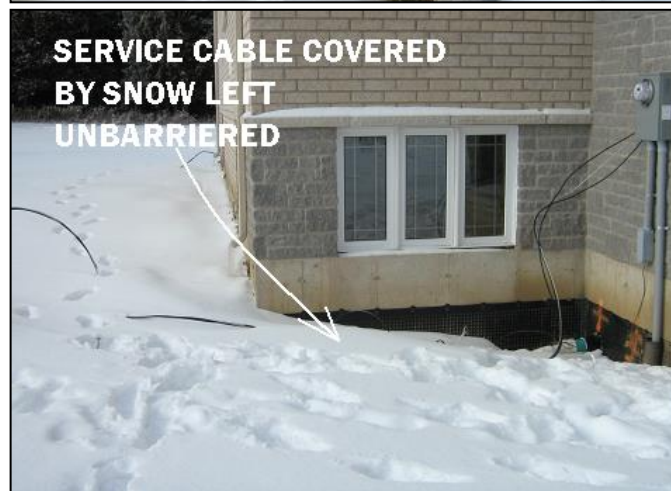
Common hazards ESA has found include:

- Service cables laid on the ground unprotected, unidentified and unbarriered
- Unbarriered overhead service cable without adequate clearance
- Service cables entering side of meter base with no box connector, exposing live terminals to the public
- Homeowner unaware of temporary service on residential property
- Members of the public exposed to accessible bare neutral conductor

- LDCs review all temporary construction practices to determine which ones are common occurrences, and provide approved plans, drawings and/or specifications for the work;

- LDCs create and approve plans, drawings and/or specifications for temporary installations including ones that are **not** considered to be common occurrences or follow applicable clauses in OESC section 66 or section 76;

- Review the definition of “No undue hazard” or “site left in safe condition” (as per the LDC Construction Verification Program) with staff involved in the installation of temporary services and staff who inspect the installation; and
