Meter Base Failures

Distribution Company Awareness

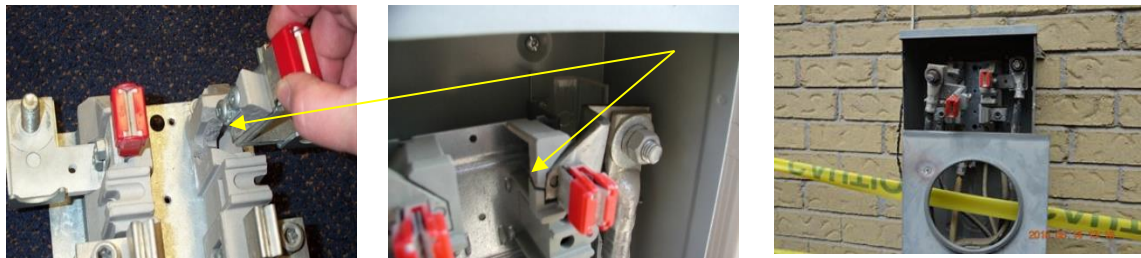
Conductors shorting to meter base covers upon removal of a meter from the meter base is a safety concern. Failure analysis of the equipment indicates that downward pressure of the supply cables can cause cracks or breaks in the porcelain or plastic of the meter base socket. When the meter is removed from the meter base, the supply conductor can make an electrical connection to the meter cover.

When a meter base's socket is damaged and needs replacement, the Electrical Distributor should contact a Licenced Electrical Contractor or the owner should be made aware of the issue. Arrangements can be made for a Licenced Electrical Contractor to implement repairs as per the requirements of the Ontario Electrical Safety Code.

Electrical Distributor's trained and qualified workers should be informed of the safety concern and take proper precautions. Actions may include:

- Identifying all potentially problem meter bases with an indicator, such as a warning sticker
- Arranging for isolation by the Electrical Distributor at the transformer before pulling the meter, on problem meter bases
- Ensuring use of proper PPE and meter pulling tools, which direct any hazard away from workers
- Ensuring secondary cables are installed with sufficient slack
- Performing meter base socket retrofits, where possible
