Electrical Distribution Safety

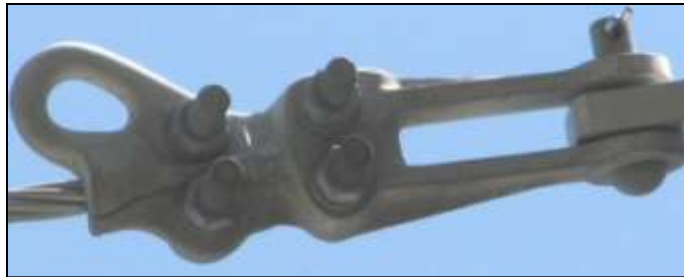
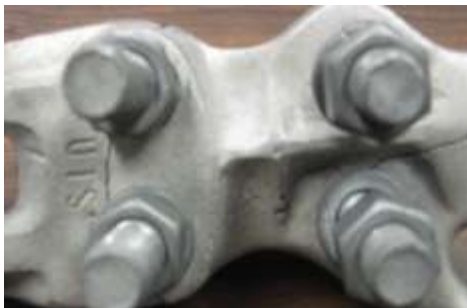
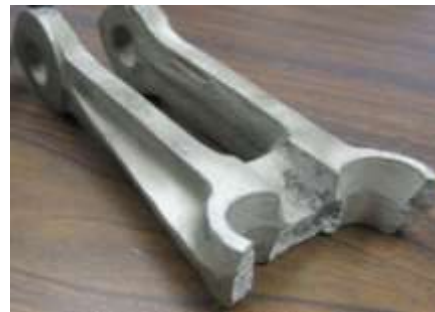
Recently ESA was informed of an incident in which a 16kV powerline fell to the ground due to equipment failure of a straight deadend clamp, Kabar Cat. #K-240-1. As a proactive approach, the LDC inspected other deadend clamp installations including installations of deadend clamps from other manufacturers. Cracks were found in other locations totaling 23 which were Kabar deadend clamps. The LDC advises

Common findings were longitudinal cracks on the underside at the cable support end and separation of the body. The LDC sent samples of the Kabar deadend clamps to be tested by an independent organization. The LDC is currently replacing all the Kabar line clamps across their service area. During the LDC inspection, deadend clamps from other manufacturers did not exhibit cracks. The CSA specification for this clamp is C83.71-96.

- LDC's take a proactive approach and do a visual inspection of their system that may have the Kabar K-240-1 straight deadend line clamps in use.
