Electrical Distributor Technical Bulletin

In-Line Disconnect Switches

Electrical Distribution Safety

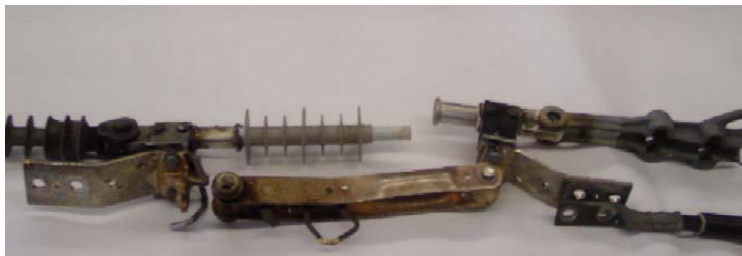
With the switch type shown above there are 2 current paths. "Path A" shows the desired current path, through a wedge connector, to the terminal pad, and through the switch blade. If "Path A" develops a high resistance, more current will be forced through the undesired path indicated by "Path B". The current along "Path B" can cause heating issues, leading to end fitting separation.

ESA recommends that crews are made aware of this issue and inspect for any visible signs of cracking. It is important that proper connections are made, including proper cleaning and abrading of the conductor and the use of oxide inhibitor. LDCs could investigate the use of dead-end insulators to increase the impedance of current through "Path B".
