Thimble Clevis

Distributor Awareness

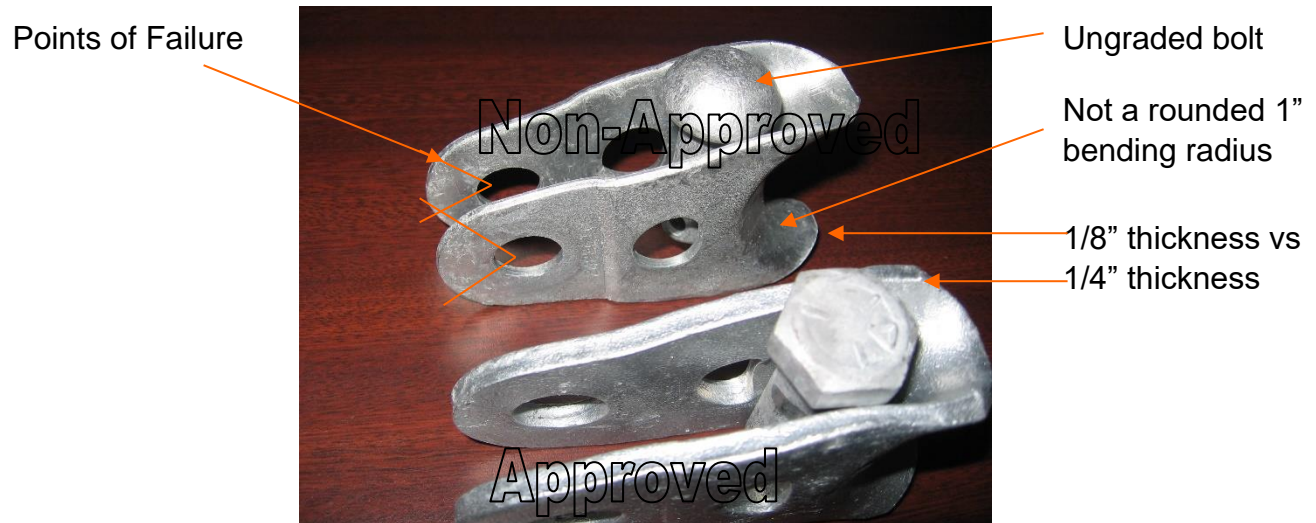
- Failed equipment was found to be a non-approved Thimble Clevis (Pig's Ear)
- Installed Thimble Clevis broke at the "Points of Failure" indicated below
- Thimble Clevis was found to be half the thickness of the approved part
- Non-uniform radius of curvature could lead to high stress points
- Bolt was ungraded

Electrical Distributors should review their Thimble Clevises to ensure only approved equipment is in stock and remove non-approved equipment from the distribution system.
