### Background

This document is intended to outline factors to be considered when deciding whether to disconnect a damaged consumer service or to leave it energized.

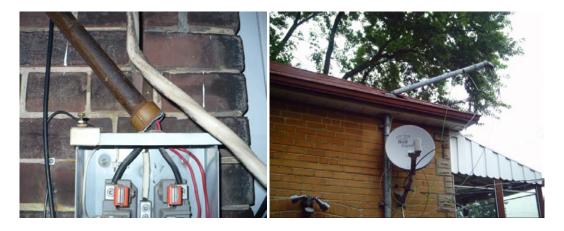
#### Example 1: Damaged metallic consumer service mast

When a rigid steel metallic mast or consumer service conduit is broken or creased, from being bent, the integrity of the conductors due to sharp edges inside the mast cannot be determined. The following steps shall be taken:

- No attempts shall be made to straighten the mast or consumer service conduit ;and
- Service must be immediately isolated and de-energized by the LDC.

The LDC may provide a temporary feed directly to the meter base when the following conditions are met. (See Electrical Safety Authority Distribution Bulletin #DSB-02-08 <a href="http://www.esasafe.com/assets/files/esaeds/pdf/dsb/DSB-02-08.pdf">http://www.esasafe.com/assets/files/esaeds/pdf/dsb/DSB-02-08</a>

- Consumer service conductors entering the side of the meter base must have a suitable box connector to avoid exposing live terminals to the public
- Temporary supply service cables must be identified and barriered
- Homeowner must be aware of temporary supply service on his/her residential property
- · Members of the public shall not be exposed to accessible bare neutral conductor
- An ESA Hazard Notification shall be initiated and the customer shall be advised repairs are required.

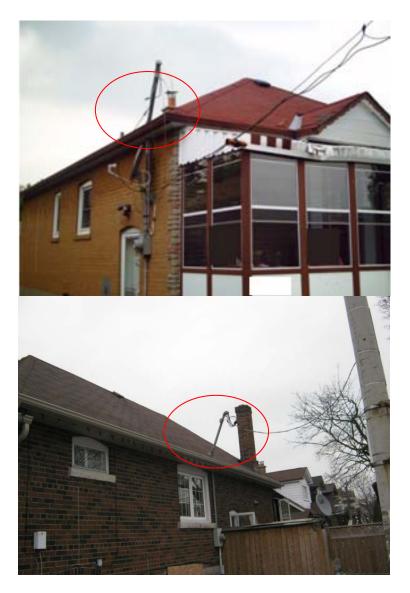
### **Example 2: Slightly bent metallic consumer service mast**

If a rigid steel metallic mast or consumer service conduit is bent, not cracked, and the bend is unlikely to damage the consumer service conductor, the service may be left energized temporarily if it meets the following:

- Ensure the terminals/supports inside the meter base are not damaged;
- Overhead conductors shall be protected as to reduce the probability of exposure to electrical safety hazards.
- An ESA Hazard Notification shall be initiated and the customer shall be advised repairs are required.

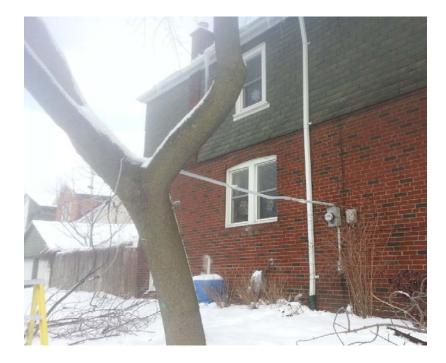
### Example 3: Damaged non-metallic (PVC) consumer service conduit

If a non-metallic (PVC) consumer service conduit is damaged, either broken or pulled apart, the service may be left energized temporarily if it meets the following:

- Ensure the conductor insulation is intact;
- Ensure the terminals/supports inside the meter base are not damaged;
- Overhead conductors shall be protected as to reduce the probability of exposure to electrical safety hazards.
- An ESA Hazard Notification shall be initiated and the customer shall be advised repairs are required.

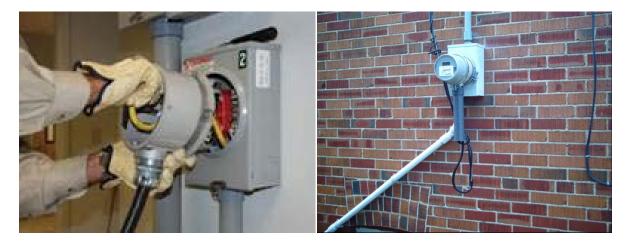
In addition, ESA also recommends where possible to use Meter Socket Adapters for temporary connections:

It is imperative that the continuity of the neutral conductor be assured. Loss of neutral continuity may create dangerous voltage imbalances on the consumer's service and distribution equipment. It is not acceptable to rely on the service ground conductor to act as a neutral, even on a temporary basis.
